PHASE II ENVIRONMENTAL SITE ASSESSMENT MERIDIAN – WEST CAMPUS UPPER PLATEAU

Project No. 13226.003

January 17, 2022

Subject: Phase II Environmental Site Assessment
Meridian - West Campus Upper Plateau
Riverside, California 92508

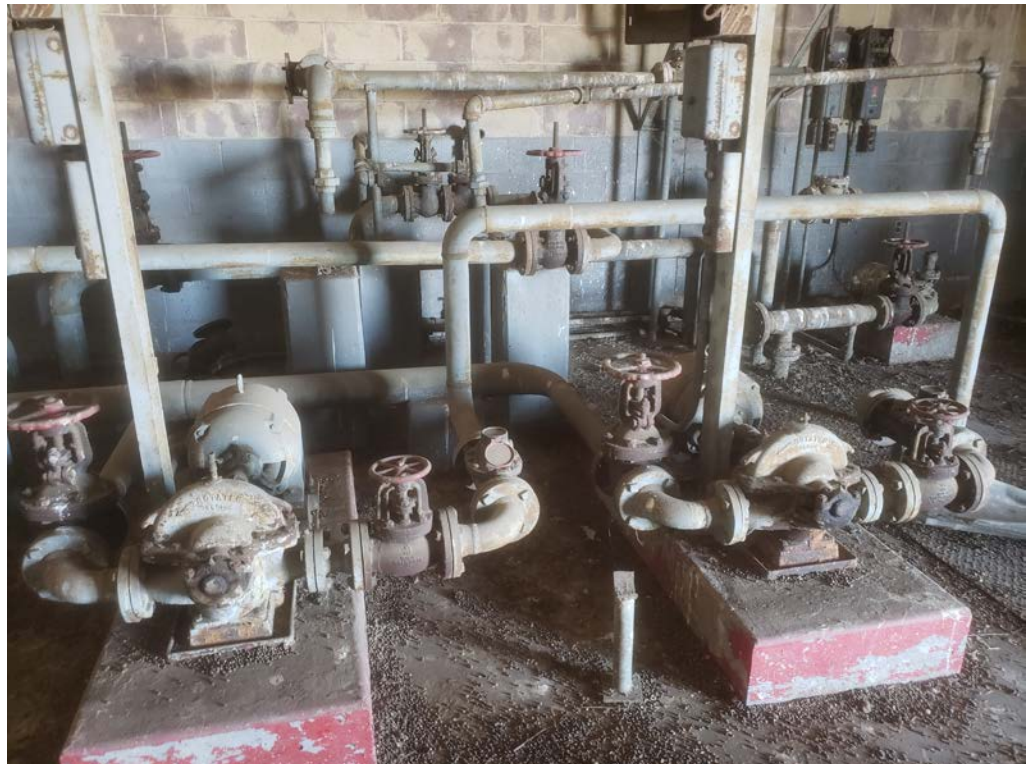
Client Name:
Meridian – West Campus Upper Plateau**Site Location:**
Riverside, California**Project No.**
13226.003**Photo No. 3****View of Direction of Photo:**

Building 2 - The interior of Building 2 contained three tanks of what appeared to be petroleum liquids, and a large amount of process piping (both above the floor and in subgrade concrete-lined trenches) indicating manufacturing processes involving liquids. The manufacturing piping and equipment, and evidence of liquid processes, is a concern, and assessment of the soils beneath this building is recommended.

Interior of Building 2 – southern most wall with various piping and pumps that may be connected to water cooling tower (located on other side of wall in background).

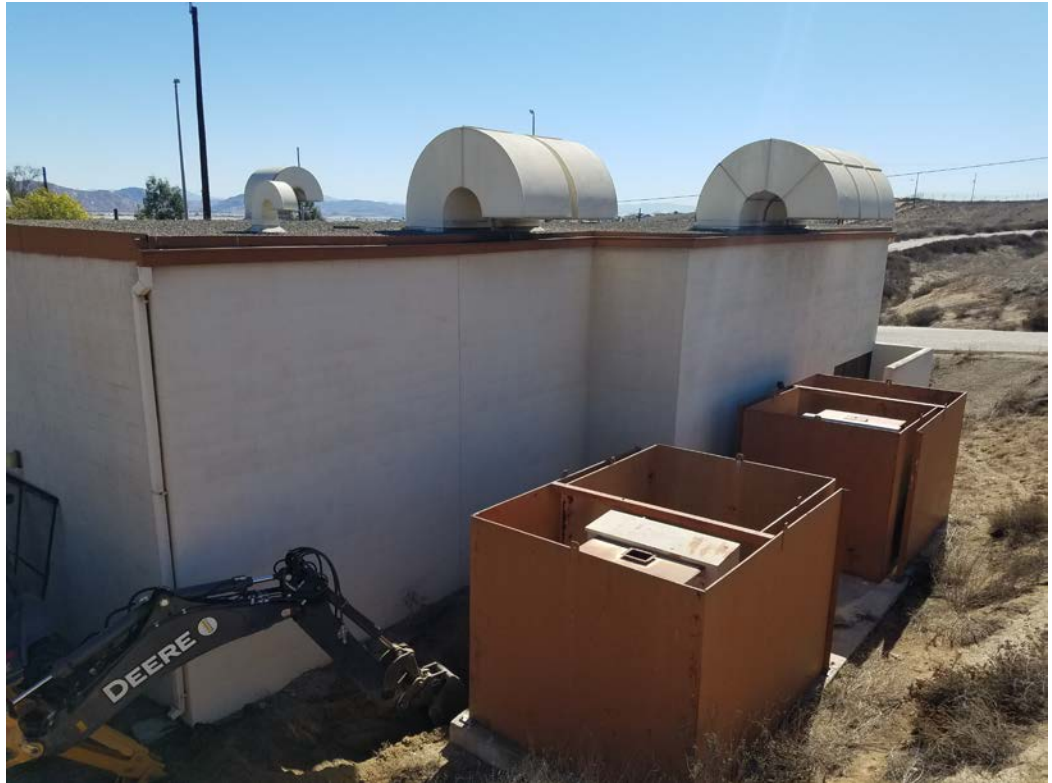
**Photo No. 16****View of Direction of Photo:**

Pad mounted electrical transformers on west side of Building 5. Each transformer surrounded by steel shrouds.
