Phase II Environmental Site Assessment

PHASE II ENVIRONMENTAL SITE ASSESSMENT MERIDIAN – WEST CAMPUS UPPER PLATEAU

Project No. 13226.003

January 17, 2022

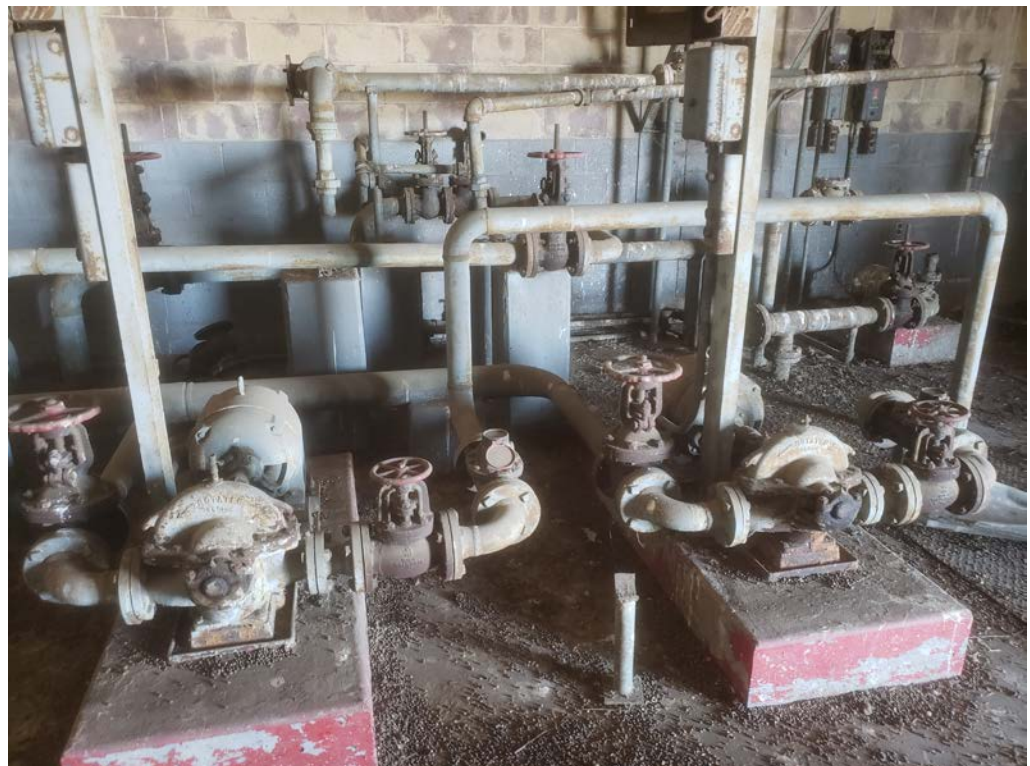
**Photo No. 2****View of Direction of Photo:**

Interior of Building 2 – southern most wall with various piping and pumps that may be connected to water cooling tower (located on other side of wall in background).

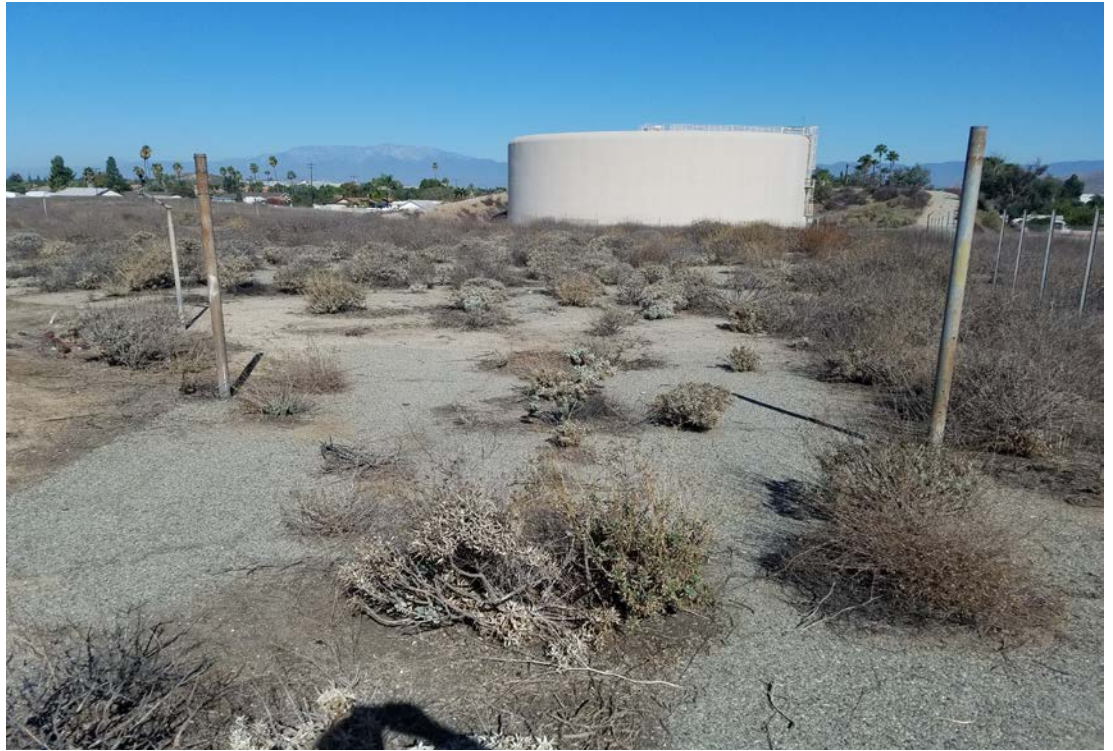
Client Name:
Meridian – West Campus Upper Plateau**Site Location:**
Riverside, California**Project No.**
13226.003**Photo No. 3****View of Direction of Photo:**

U-Shaped Feature - From at least 1962 to 1989, an unknown U-shaped feature (likely concrete pad) and associated access road existed near the northern edge of the Site. Its use is unknown. Limited shallow soil sampling (0-5 feet bgs) focused around the southern, western and northern edges is recommended.

View of asphalt access road leading to unknown U-Shaped asphalt area with former fencing around it.

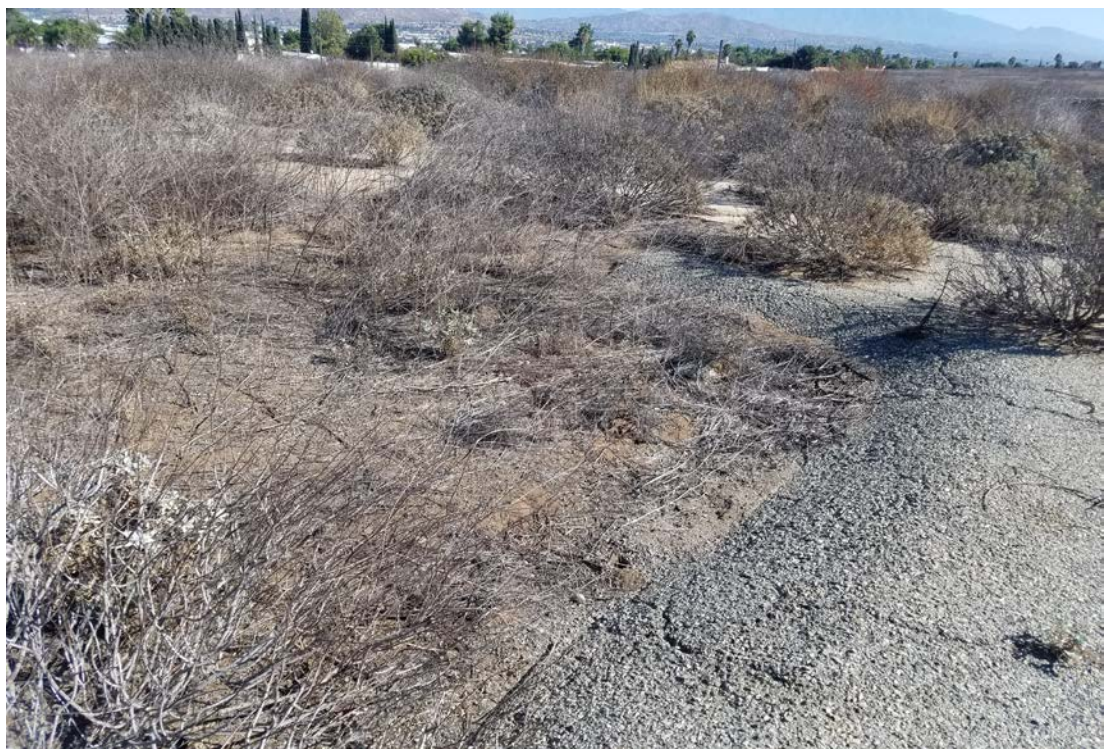
**Photo No. 4****View of Direction of Photo:**

View of U-shaped asphalted area at ground surface

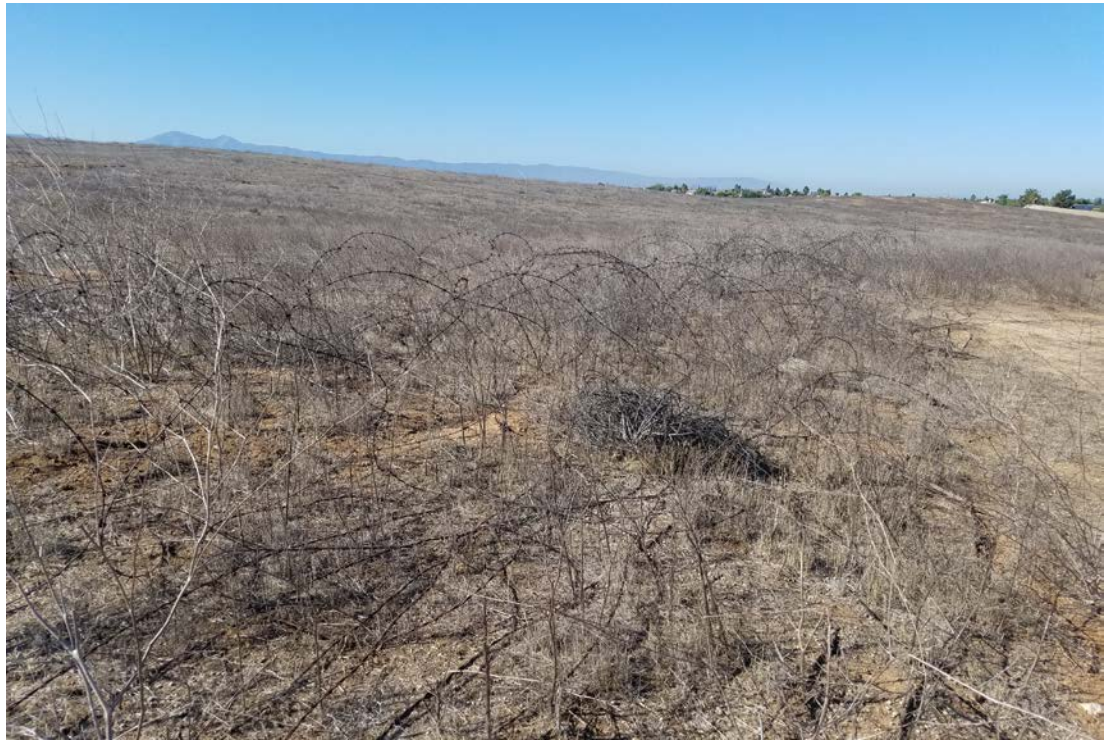
Client Name:
Meridian – West Campus Upper Plateau**Site Location:**
Riverside, California**Project No.**
13226.003**Photo No. 5****View of Direction of Photo:**

Barbed wire on ground surrounding unknown U-shaped asphalt feature.

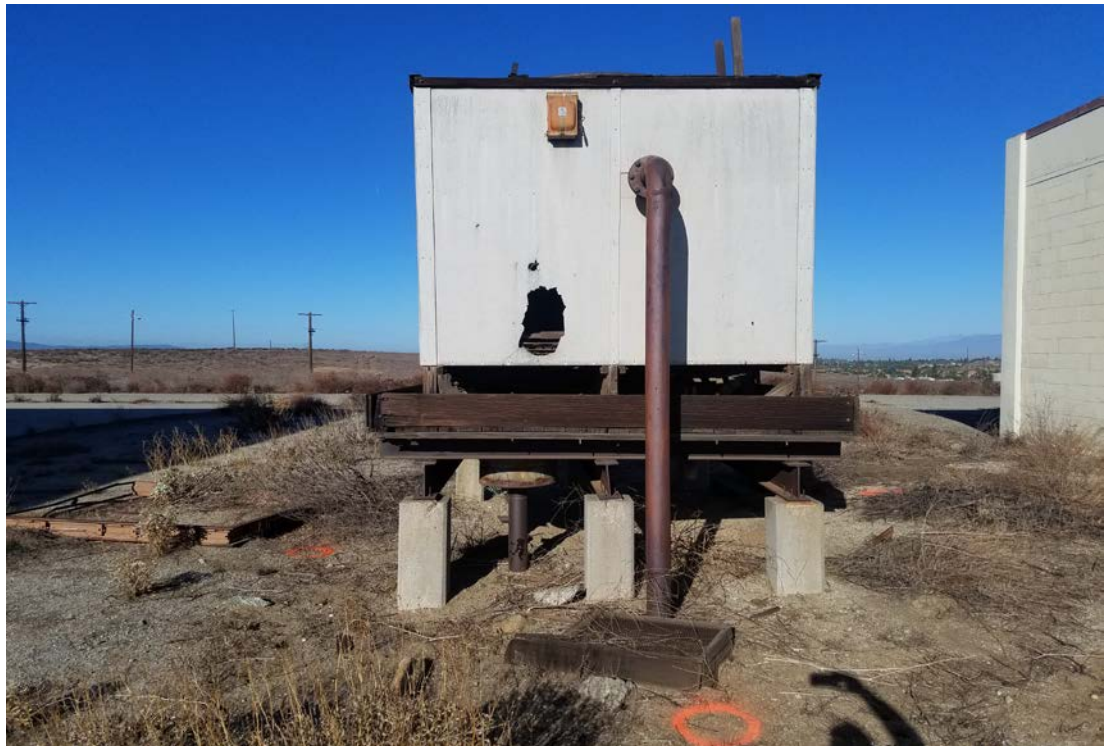
**Photo No. 8****View of Direction of Photo:**

Water Cooling Tower - A water cooling tower was observed between Buildings 1 and 2 with evidence of subsurface piping. Older water treatment chemicals are a concern, and limited shallow soil sampling around the base of this cooling tower is recommended. Assessment of the subsurface piping run is also recommended (geophysical survey). The cooling tower itself may contain asbestos containing materials, and its material should be sampled in this regard.

Description:Abandoned water
cooling tower with
line leading into the
subsurface. Bldg 2 at
right. Bldg 1 at left
(shadow).

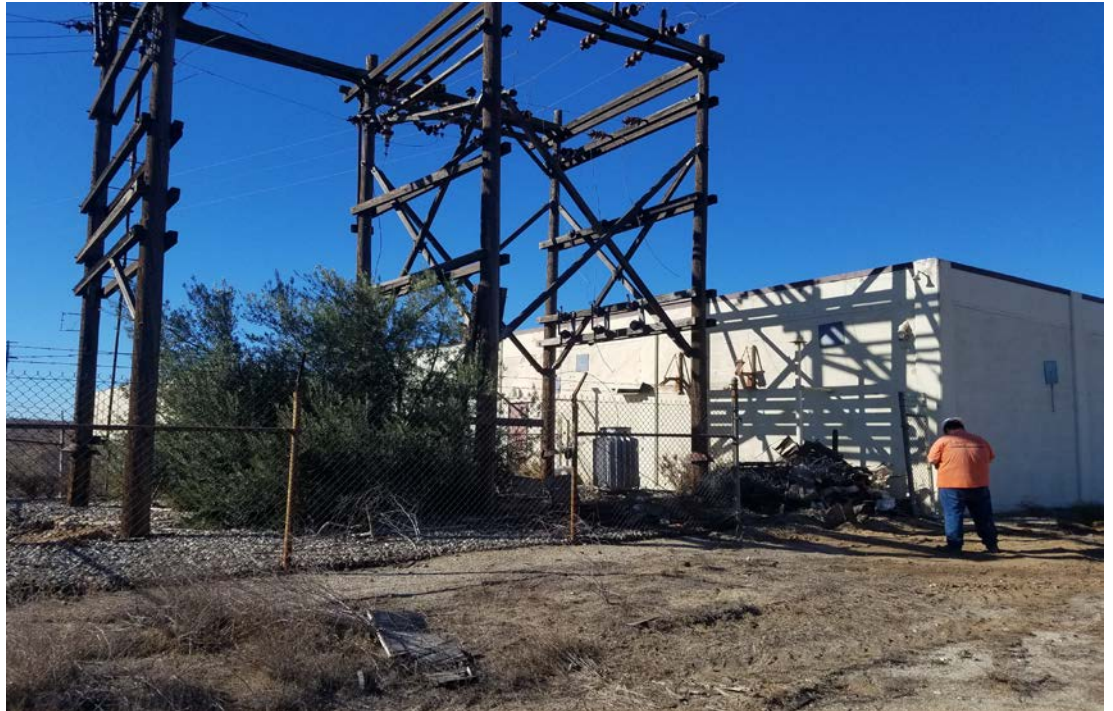
Client Name:
Meridian – West Campus Upper Plateau**Site Location:**
Riverside, California**Project No.**
13226.003**Photo No. 11****View of Direction of Photo:**

Electrical Transformers /Equipment - Pole-mounted electrical transformer banks (substations) were observed east of Buildings 2 and Building 4, with the empty transformer cans on the ground, indicating they may have been scavenged for metals. Also, west of Building 5 are two large pad-mounted electrical transformers, with evidence of leakage onto the soil adjoining one of them. The interior of Building 5 also contains large scale electrical distribution equipment which appears many decades old. Shallow soil sampling for PCBs is recommended near all of the above-mentioned features. At the interior of Building 5, this soil sampling may be substituted with wipe samples of the concrete flooring near the electrical switching equipment.

Empty former electrical transformer housing on ground in background center.

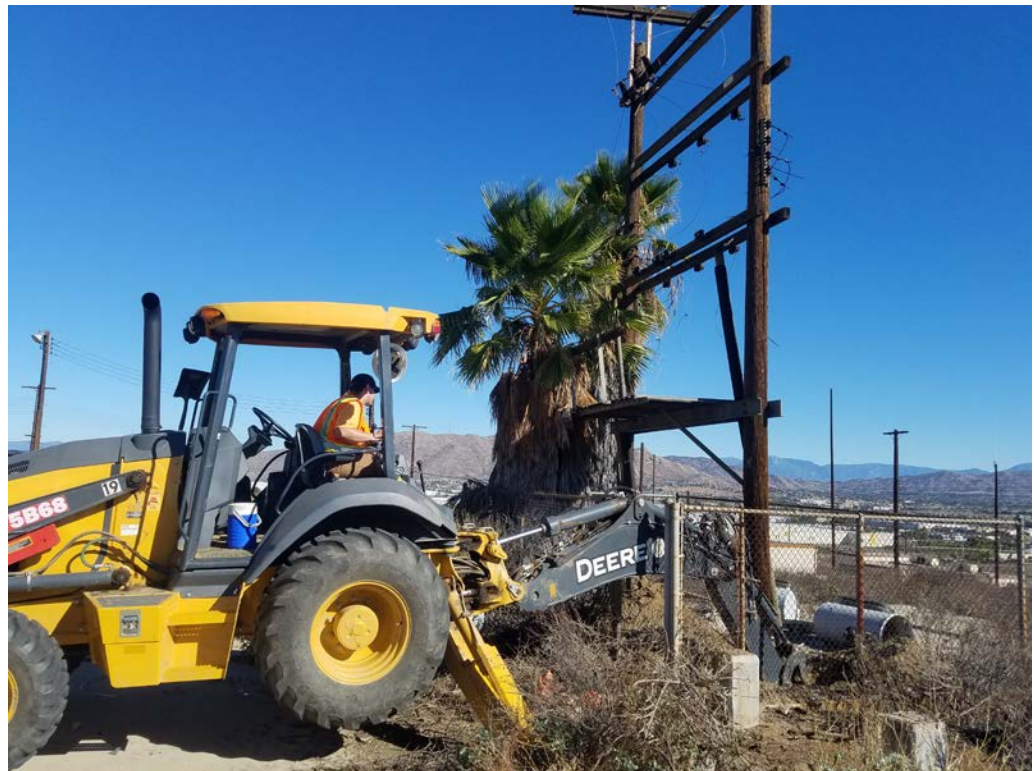
Client Name:
Meridian – West Campus Upper Plateau
Site Location:
Riverside, California
Project No.
13226.003
Photo No. 13
View of Direction of Photo:

Empty former transformer housing on ground at background right.

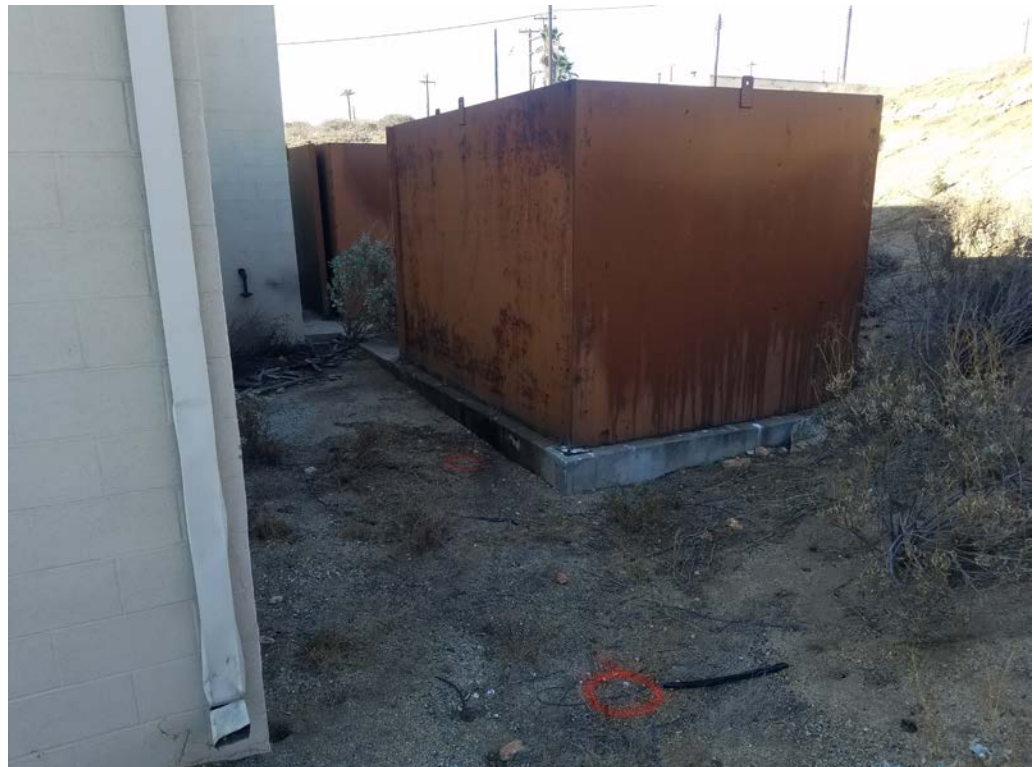
Photo No. 14
View of Direction of Photo:

Two soil sampling trenches were completed near two of the largest pad-mounted electrical transformers noted on the Site. These transformers are on the exterior west side of Building 5, a building which appears to have been a main electrical distribution building (based on relict equipment in the interior) for the former ordnance storage area.

Pad mounted electrical transformers on exterior west side of Building 5. Transformers surrounded by steel shrouding. Staining on concrete and soil near base of transformer (in foreground)

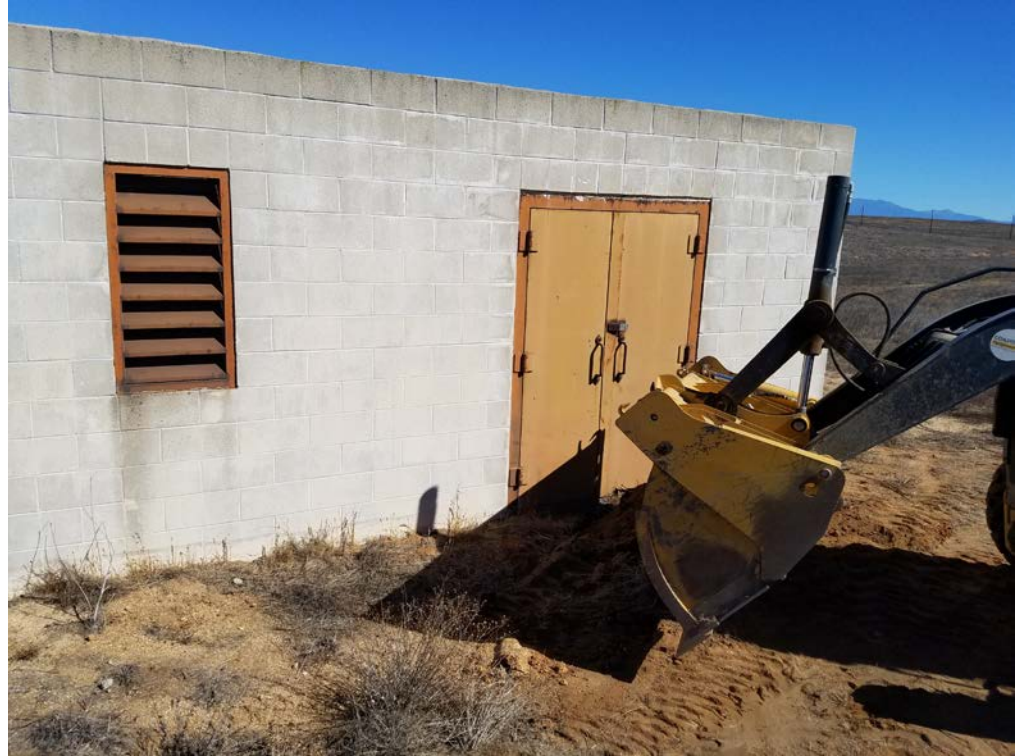
Client Name:
Meridian – West Campus Upper Plateau**Site Location:**
Riverside, California**Project No.**
13226.003**Photo No. 17****View of Direction of Photo:**

Completion and backfilling of trench PD2-1 near exterior west wall of electrical equipment enclosure.

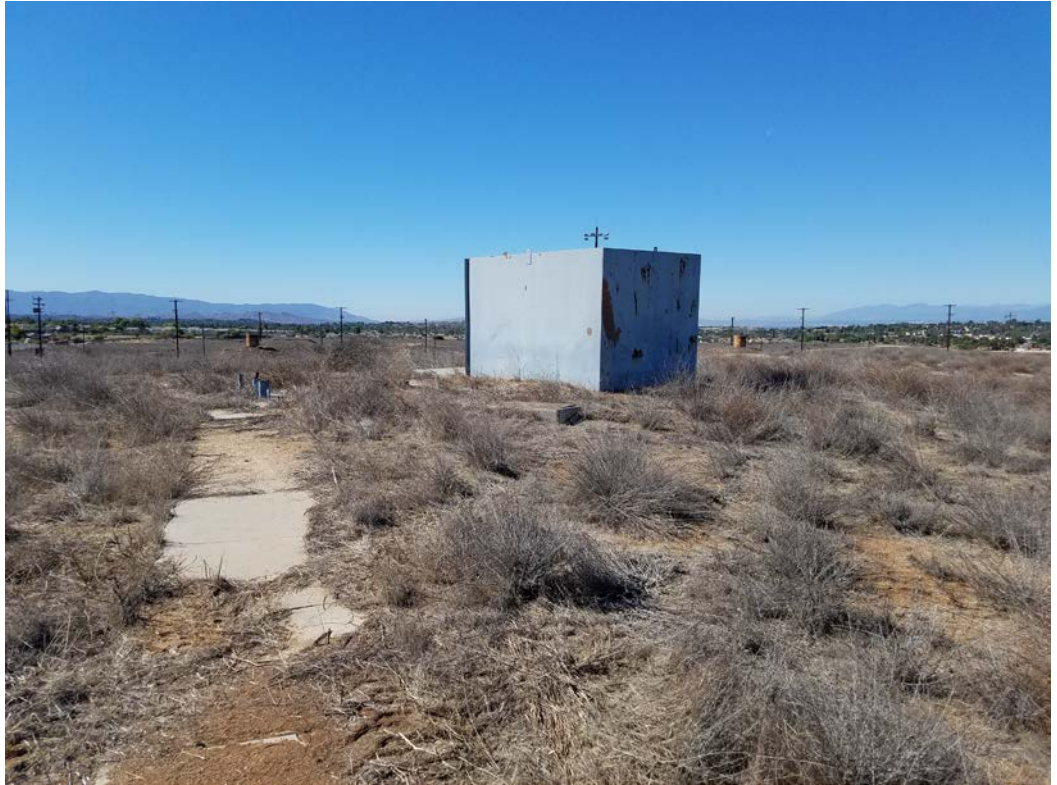
Client Name:
Meridian – West Campus Upper Plateau**Site Location:**
Riverside, California**Project No.**
13226.003**Photo No. 21****View of Direction of Photo:**

Steel shroud surrounding remnants of small electrical transformer in the ordnance bunker area.

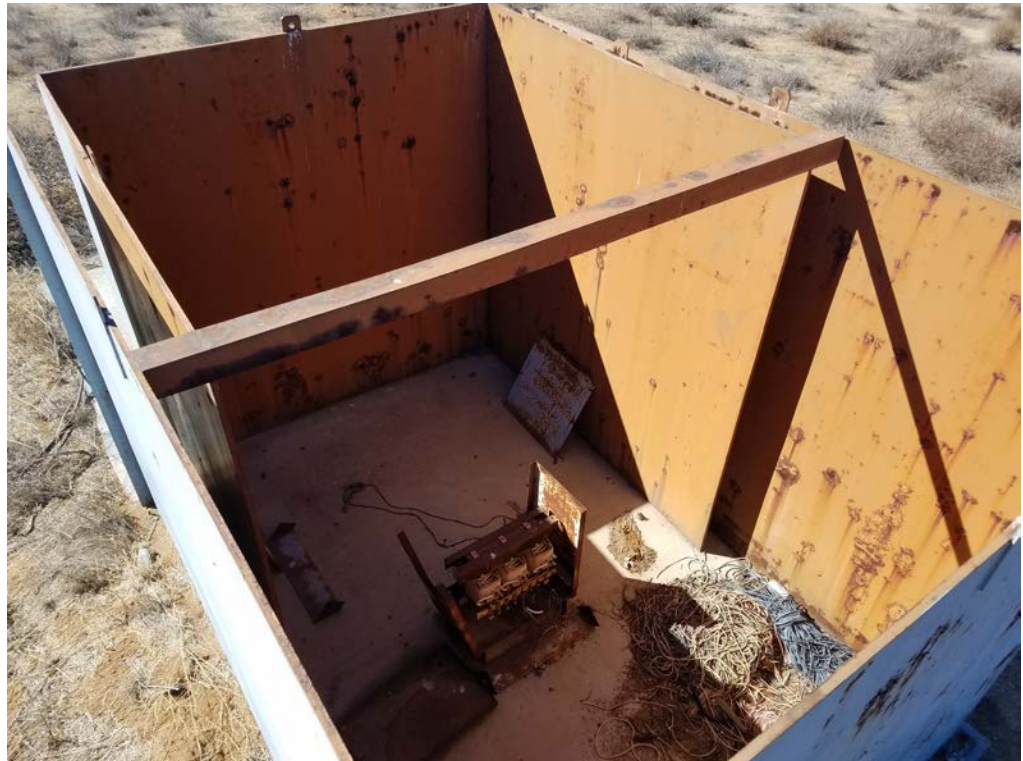
**Photo No. 22****View of Direction of Photo:**

Remnants of small electrical transformer inside of steel shrouding.
