PHASE II ENVIRONMENTAL SITE ASSESSMENT MERIDIAN – WEST CAMPUS UPPER PLATEAU

Project No. 13226.003

January 17, 2022

Subject: Phase II Environmental Site Assessment
Meridian - West Campus Upper Plateau
Riverside, California 92508

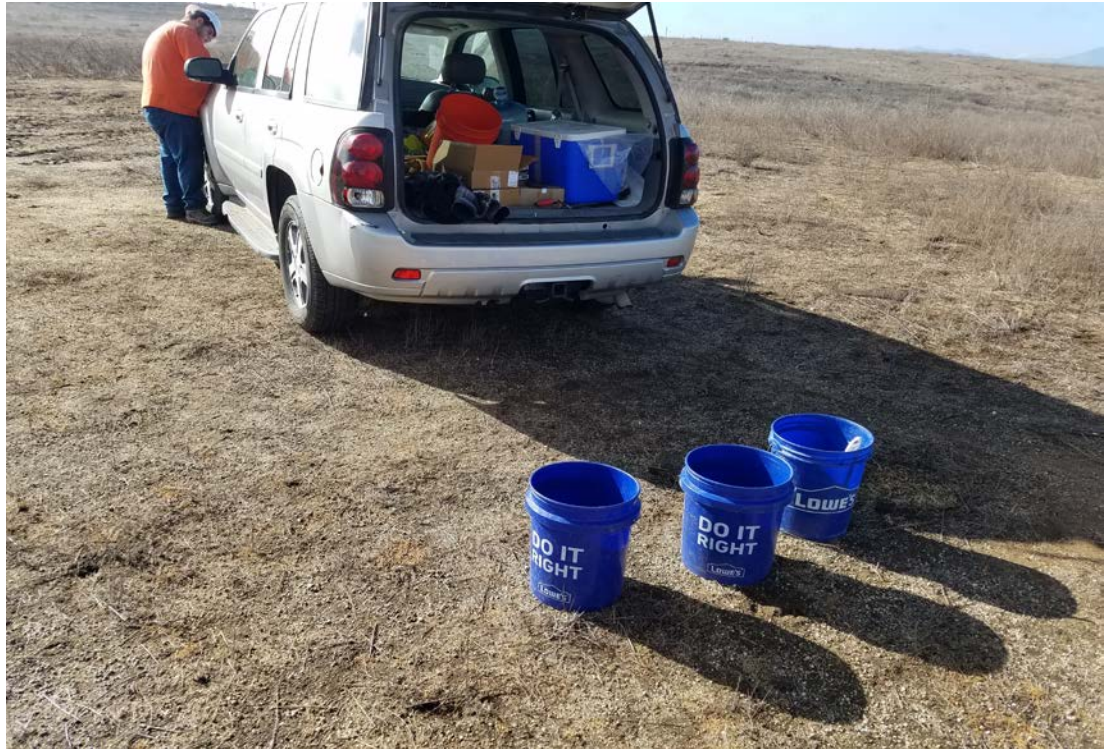
**Photo No. 8****View of Direction of Photo:**

Soil sample collection in unknown U-shaped asphalt area
