Phase II Environmental Site Assessment

PHASE II ENVIRONMENTAL SITE ASSESSMENT MERIDIAN – WEST CAMPUS UPPER PLATEAU

Project No. 13226.003

January 17, 2022

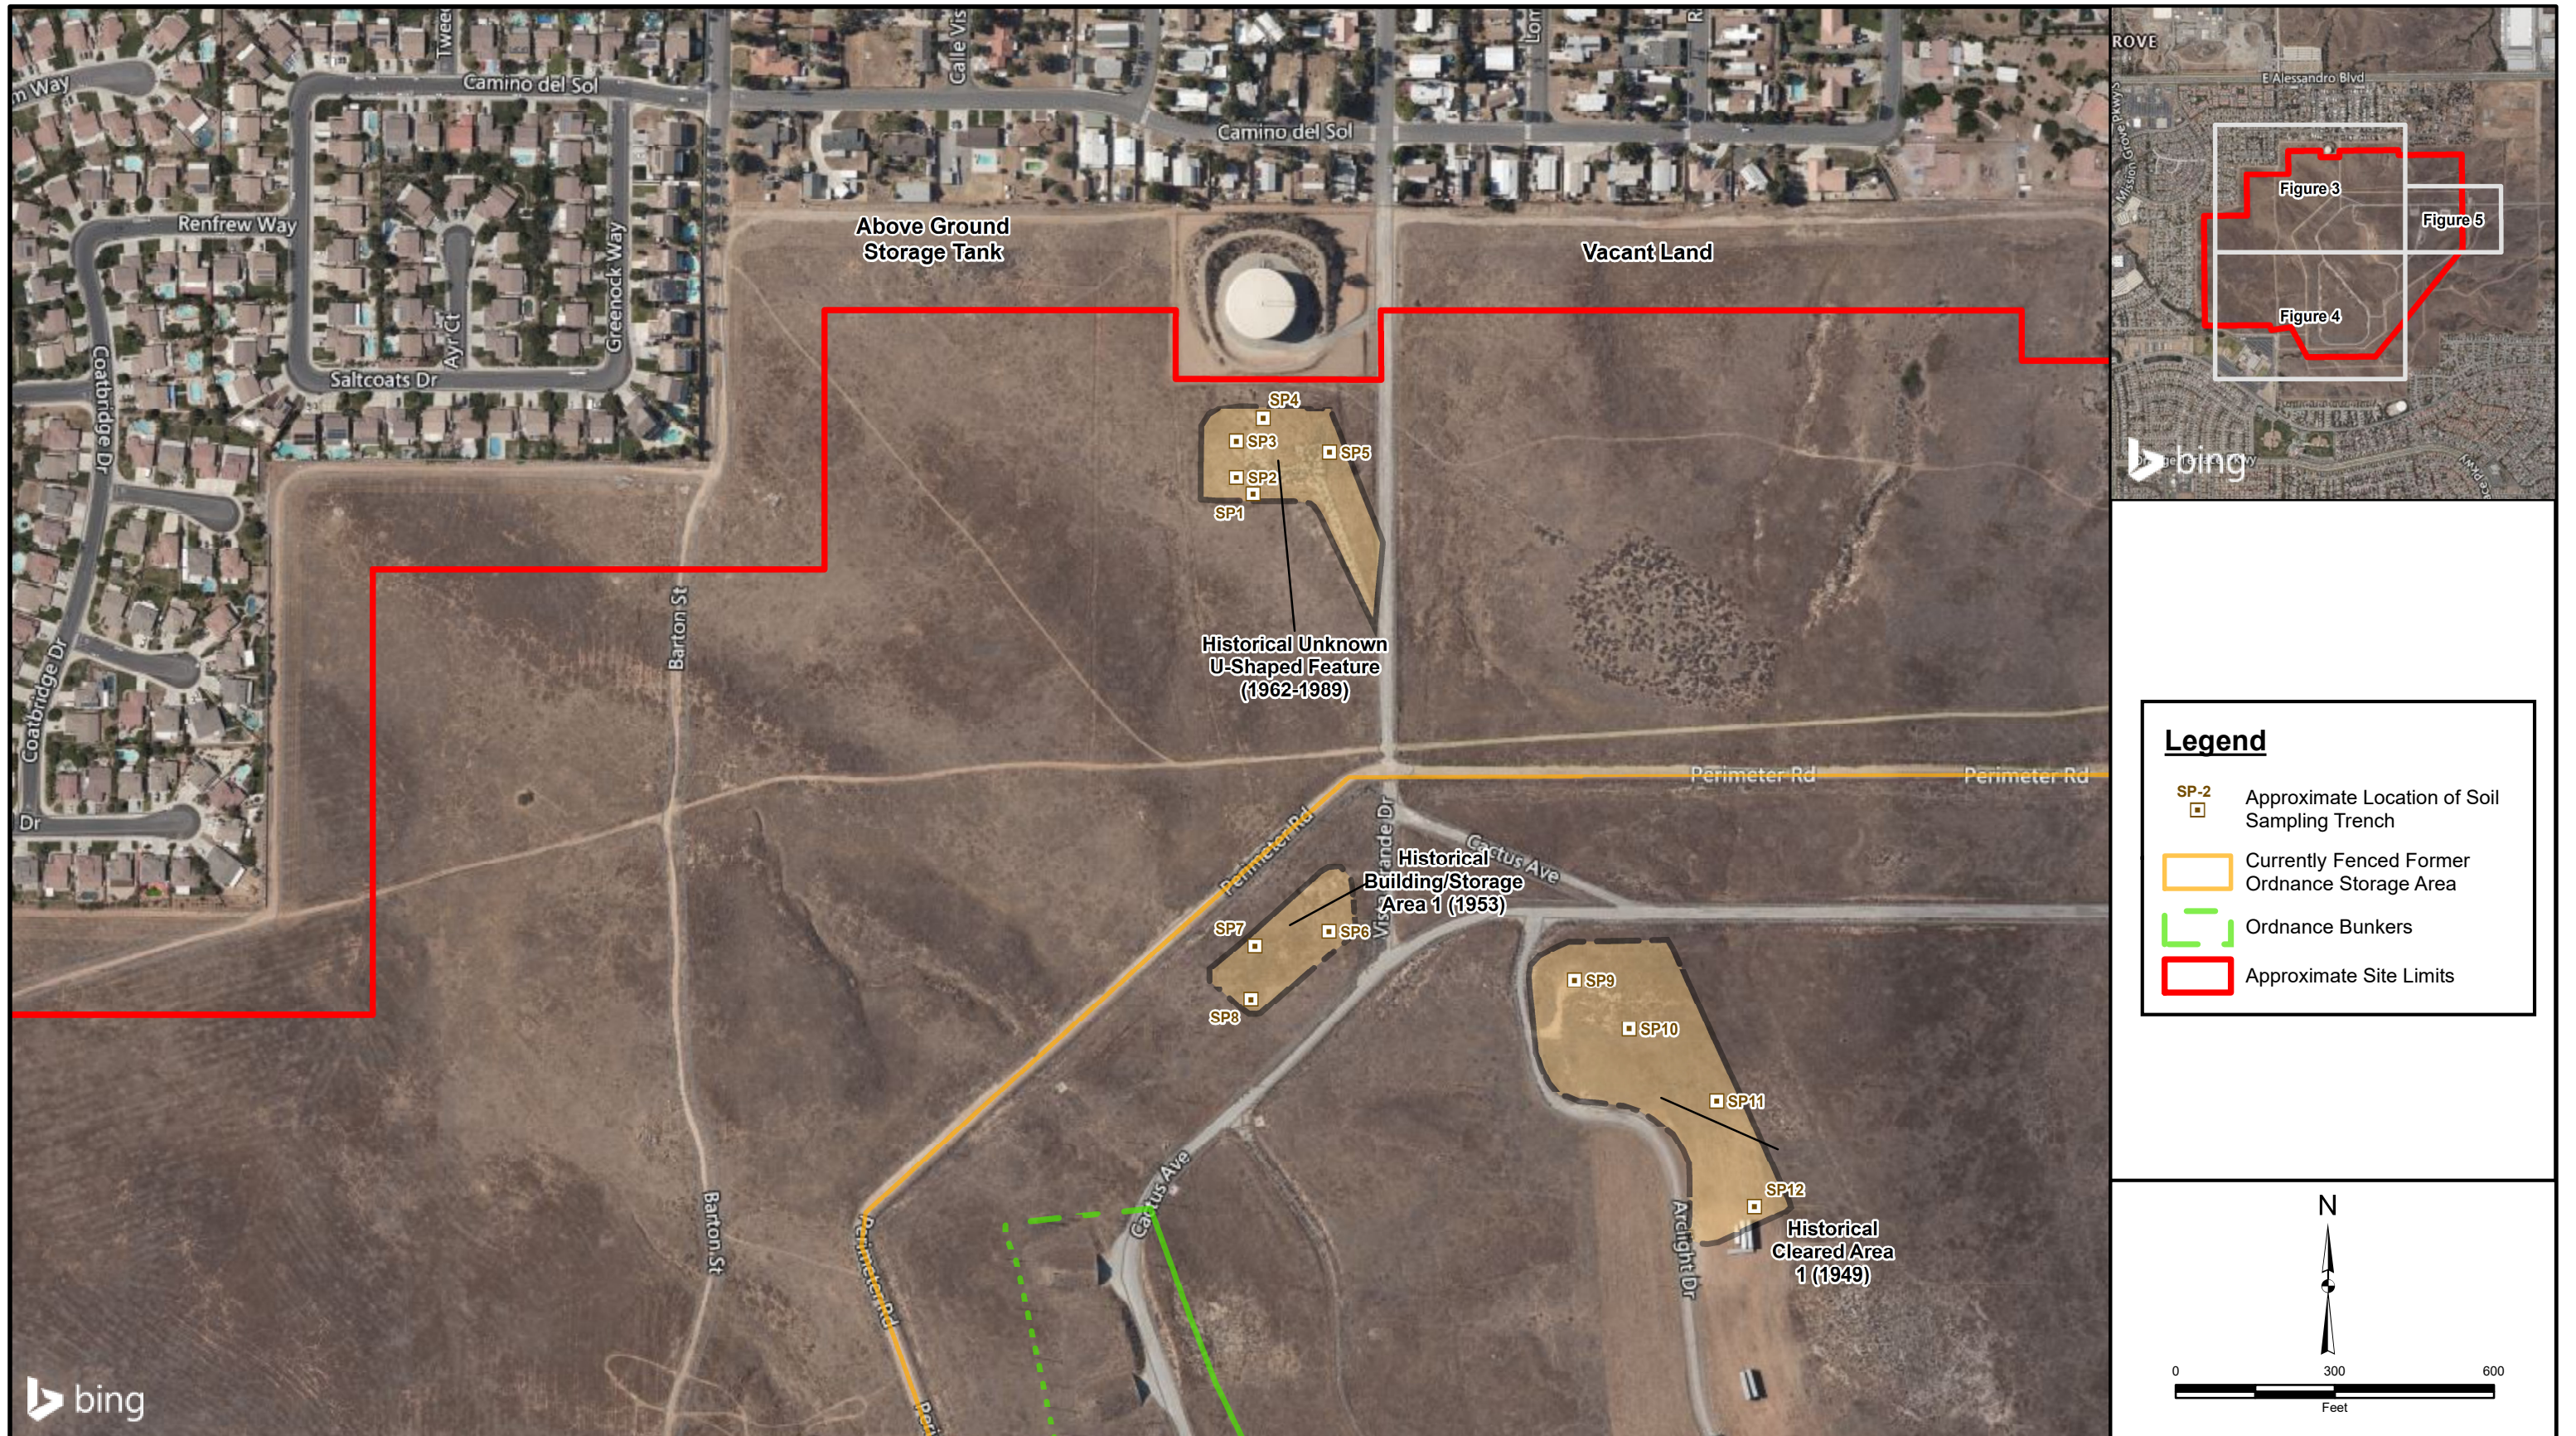
Figure 3

The locations of the sampling trenches, designated **SP1-SP5**, are shown on attached **Figure 3**. The trenches were generally completed around the U-shaped feature, with some emphasis on the southern and western sides, which appeared in historical aerial photographs to be have been actively used. Attached **Photos nos. 3-7 (Appendix B)** show this general area and associated sampling activities.

The locations of the sampling trenches, designated **SP6-SP8**, are shown on attached **Figure 3**. The trenches were randomly located over this historical clearing/building area.

The locations of the sampling trenches, designated **SP9-SP12**, are shown on attached **Figure 3**. The trenches were randomly located over this historical cleared area.

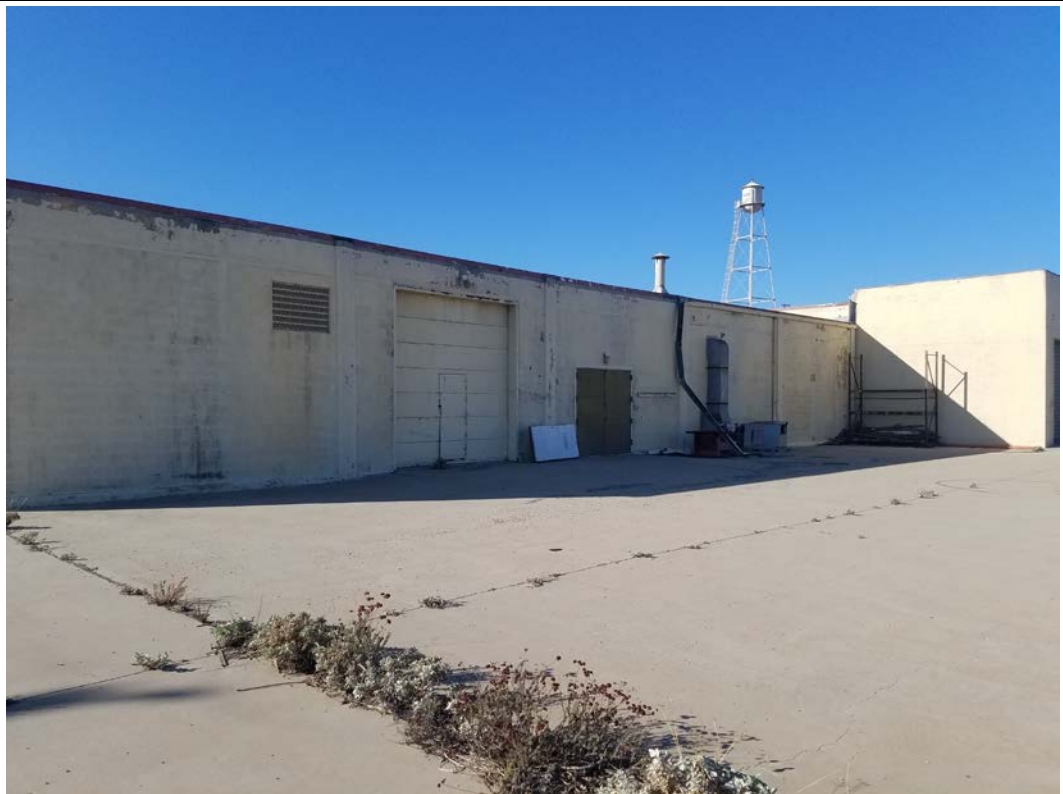
Typical building structure (Building 4)

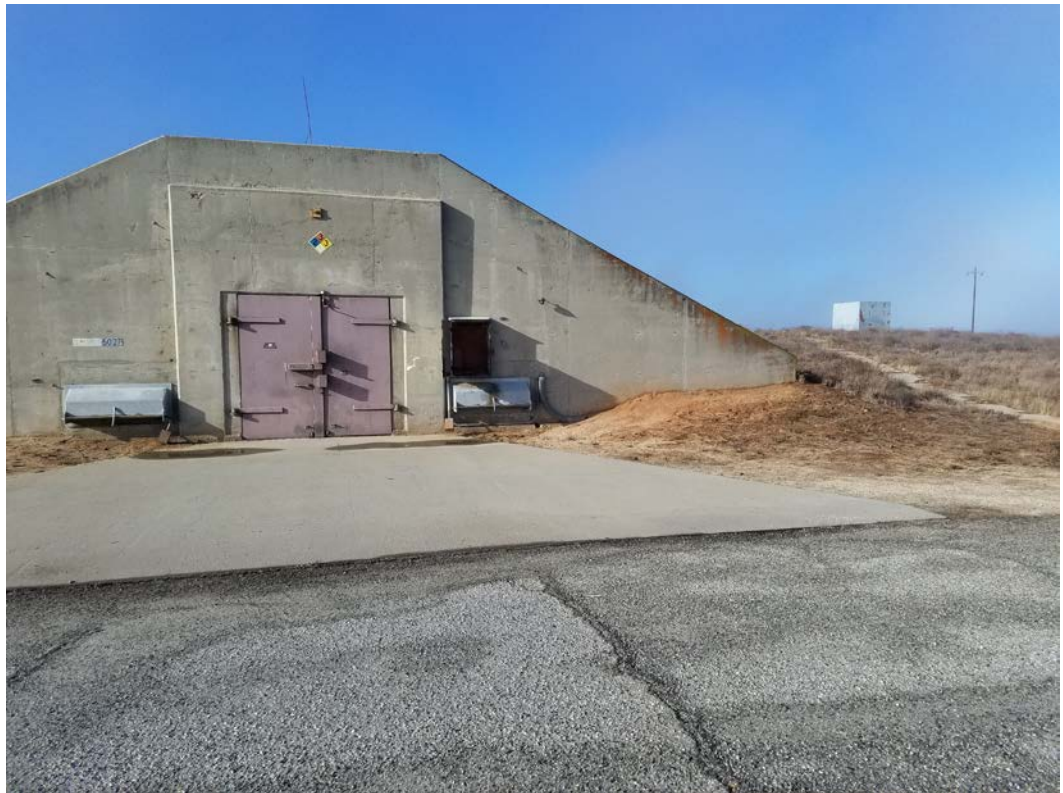
Client Name:
Meridian – West Campus Upper Plateau**Site Location:**
Riverside, California**Project No.**
13226.003**Photo No. 19****View of Direction of Photo:**

Typical ordnance bunker

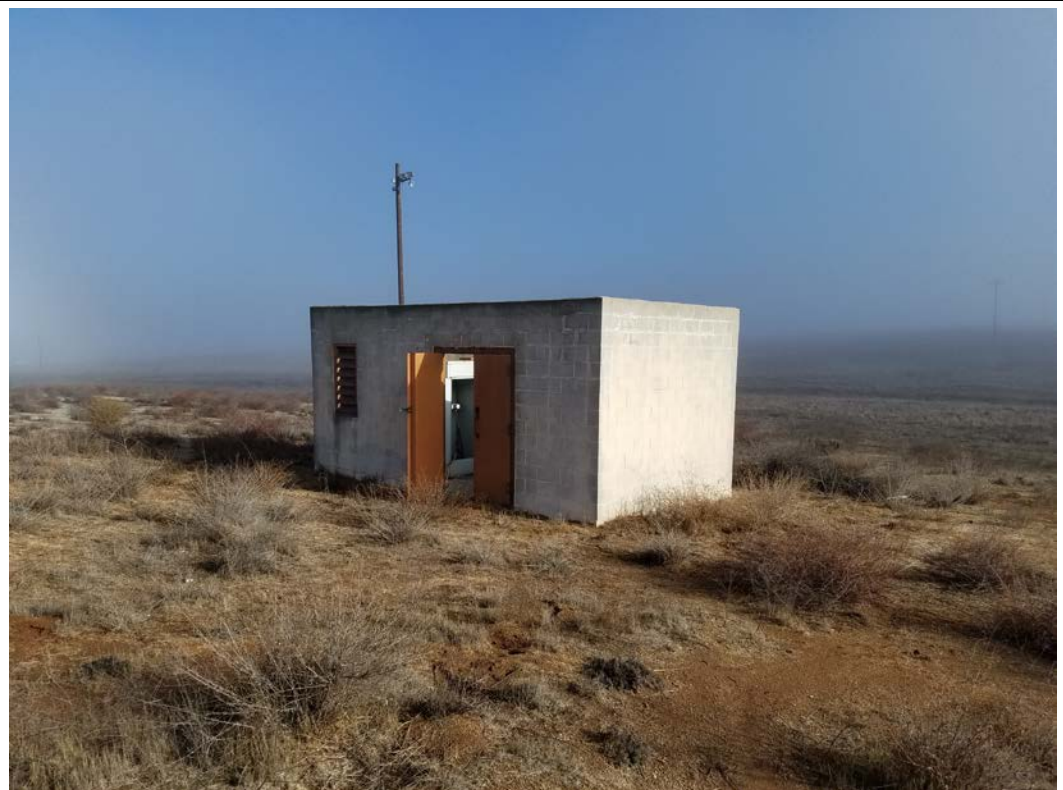
**Photo No. 20****View of Direction of Photo:**

Outbuilding adjoining NE of ordnance bunker area (pad mounted electrical transformer /equipment inside.
